COMPENDIUM OF POST-FAILURE ANALYSIS TECHNIQUES
FOR COMPOSITE MATERIALS

RAY GROVE, BRIAN SMITH
BOEING MILITARY AIRPLANE COMPANY
P. O. BOX 3707
M/S 73-43
SEATTLE, WASHINGTON 98124

JANUARY 1987

INTERIM REPORT FOR PERIOD JULY 1984 - NOVEMBER 1986

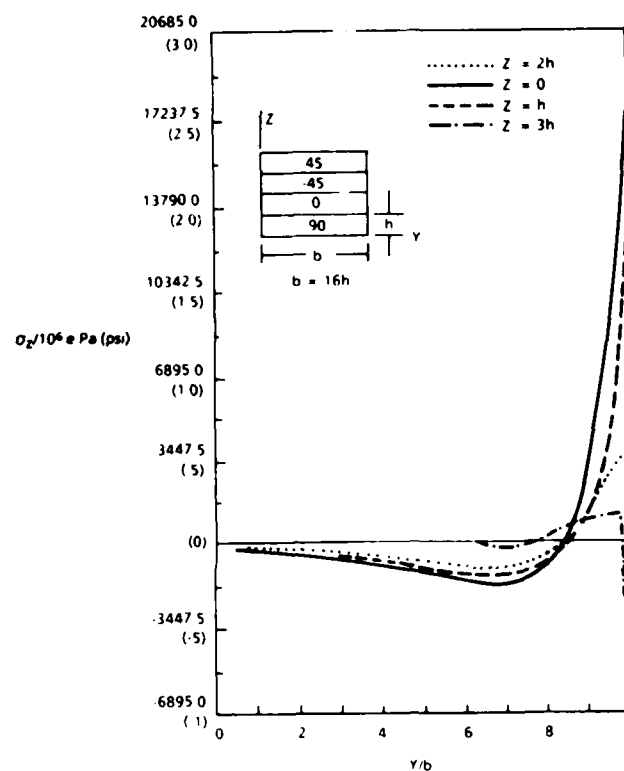
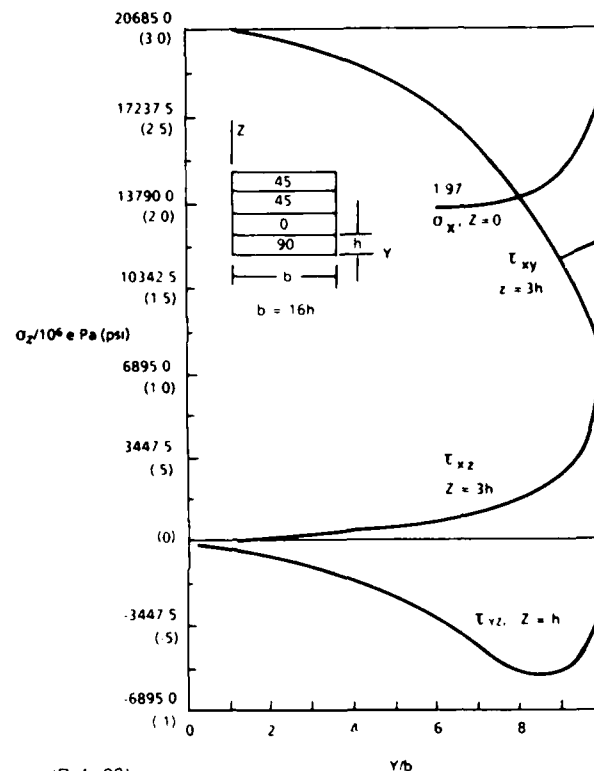
Figure 3-75. Stress Gradients Resulting From Edge Effects

Distributions along
each ply interface for
(+45/-45/0/90 degree),

Various stress distribu-
tions along several ply
interfaces in (+45/-45/0/90 degree),

Finite Element Modeling—Incorporating the effects of free edge interlaminar stress concentrations with environmental and cure stress considerations represents the next level of complexity in predicting failure onset using individual-ply failure criteria. For the failure analyst, these works are useful in that they embody considerations likely to be necessary with real-world structures. Both Crossman and Herakovich (refs. 20 and 21, respectively) observed that significant variations in stresses and strains can occur at the free edge of specimens. Both authors show the magnitude of these stresses for relatively simple layups and specimen geometries. Generally, the most significant stresses are those developed near the specimen's free edge. In analyzing these stresses, both authors employed two-dimensional finite-element grids arranged along the specimen cross-section. Using these grids illustrates the degree of complexity involved in determining the interlaminar stresses (or strains) in microscale with such design details. As noted by Crossman, particularly large gradients can occur in both Z and Y directions near the free edge (Figure 3-75). Regarding the application of individual-ply failure criteria, the large increase in σ_z , σ_x , and τ_{xz} stresses near the edge of the specimen are particularly significant, since laminate theory methods would have ignored these increases.

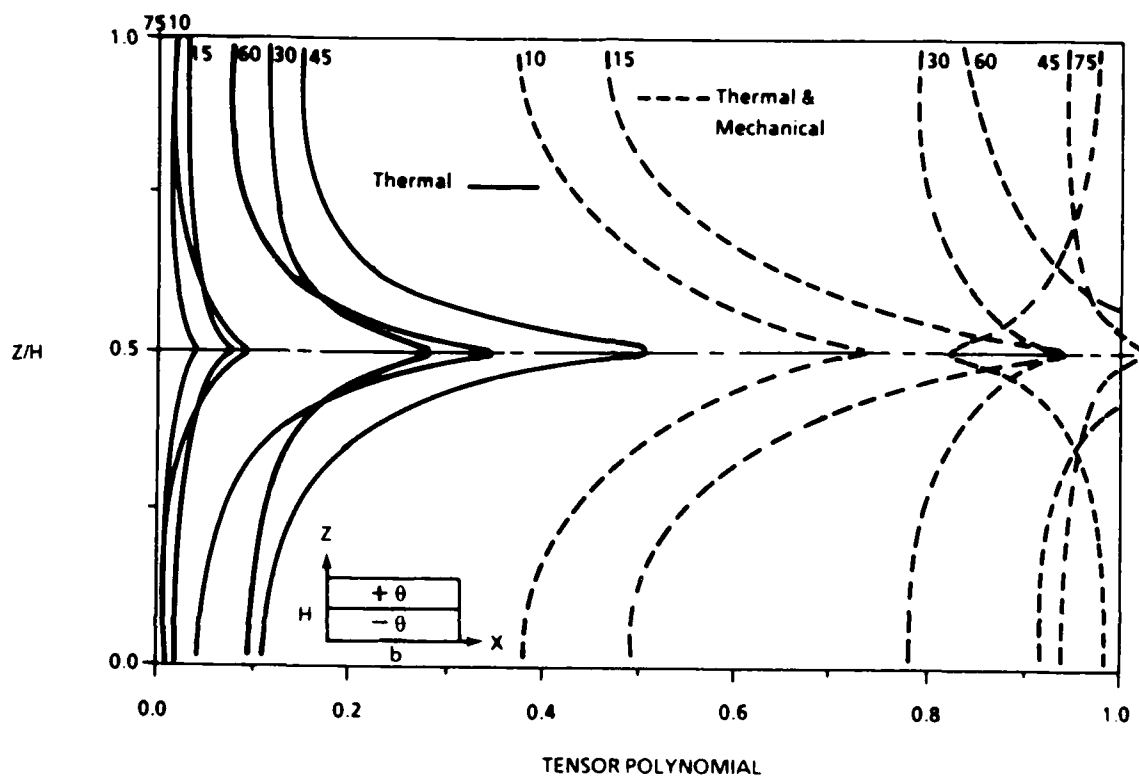
Figure 3-76. Through-Thickness Tensor Polynomial Distributions for Curing Stresses and Stresses at the First Failure (+/-) Laminates

Furthermore, Crossman and Herakovich predicted that stresses would be further influenced by internal cure stress, test temperature, and conditions of moisture absorption or desorption (Figure 3-76). In Herakovich's work, the relationship of these stresses to failure prediction were considered. Since his finite-element model examined stresses along three dimensions, it was necessary to develop a full three-dimensional failure criterion. Herakovich used the tensor polynomial criteria advanced by Tsai-Wu, in which strength tensors are given in terms of material principal strengths. As illustrated in

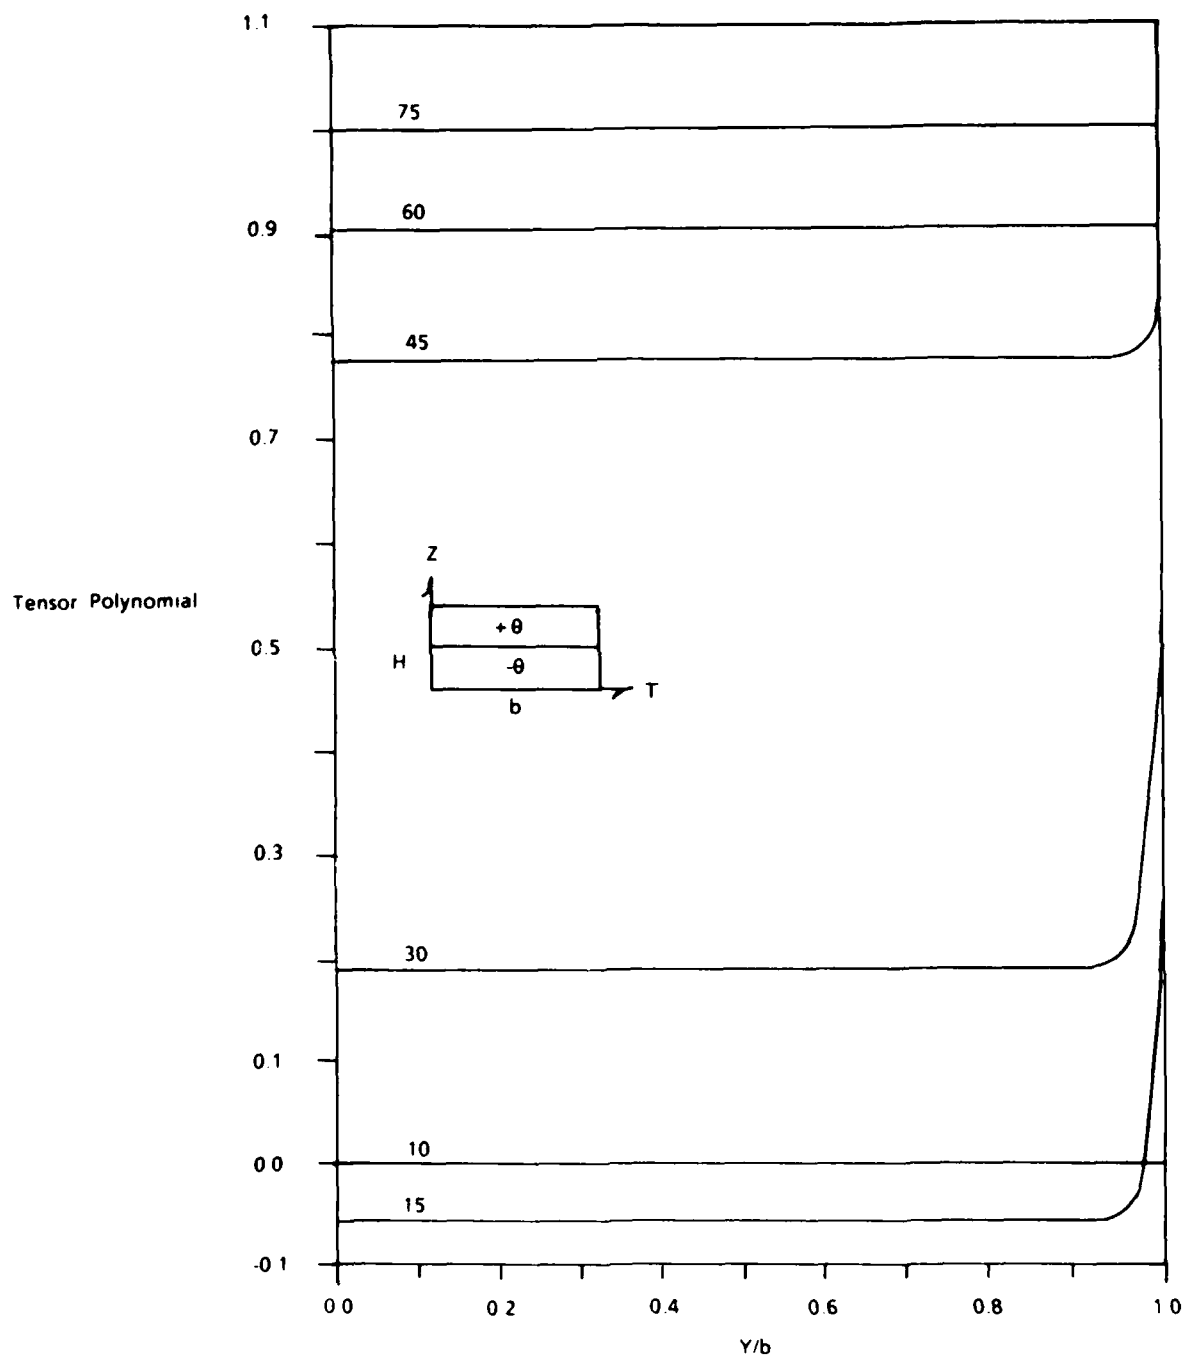
Figure 3-77. Tensor Polynomial Distributions Along the Interface of (+/-) Laminates

Figure 3-77, Herakovich predicted that the onset of failure depends quite strongly on edge stresses, particularly for small ($\pm\theta$) laminate angles. While not verified against actual test data, these results, when considered with Crossman's, clearly indicate that both edge and environmental stress effects must be carefully evaluated in predicting the onset of failure for whichever individual-ply criteria are employed.

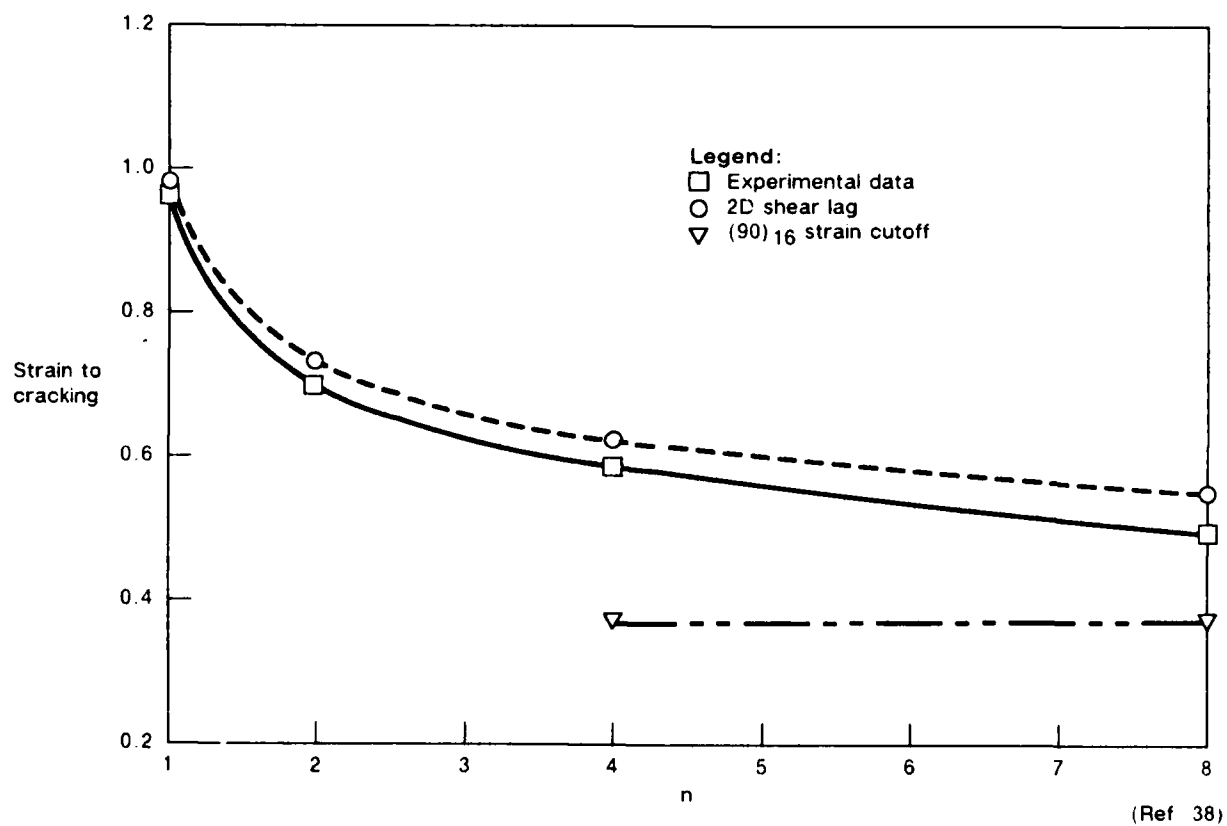
Figure 3-78. Comparison of Experimentally Derived In Situ Lamina Elastic Strains at Onset of Matrix Cracking With 2D Shear Lag Model Predictions for (0/90) T300/934 Laminate Family

In the previous paragraphs, the strain required to cause cracks parallel to the fibers (transverse matrix cracking) was assumed equal to the transverse failure strain of a 90 degree ply. However, it has been shown by numerous researchers (refs. 24 to 28) that the strain to cracking of an off-axis ply group depends upon its thickness. Flaggs and Kural (ref. 24) have clearly demonstrated that the in-situ strain to cracking decreases as the thickness of an off-axis ply group (30, 60 or 90 degree) increases (see Figure 3-78). The fact that the in-situ strength of a 90-degree ply is greater than that of a laminate composed only of 90 degree plies has been attributed to the constraint provided by the stiffer surrounding ply groups. Flaggs (ref. 28) used a fracture mechanics approach combined with 2-D shear lag analysis to successfully model the in-situ strain to cracking as shown in Figure 3-78. This model has also been applied successfully to predicting in-situ cracking of 30 and 60 degree ply groups (ref. 28).

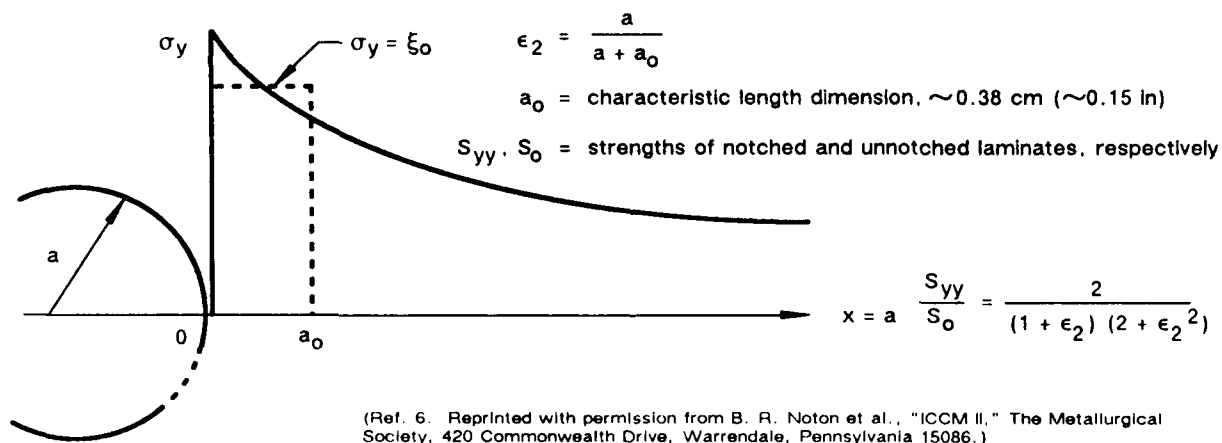
Figure 3-80. Strength Reduction of Uniaxially Loaded Plate With Circular Hole According to Average Stress Criterion

Numerous researchers have also attempted to predict the criticality of holes, cracks, and damage by empirically measuring other characteristic fracture properties, in much the same way as is done with fracture toughness (refs. 6 to 8 and 32 to 43). Two of the significant efforts include failure criteria which assume failure occurs when the stress at some distance away from the flaw reaches the ultimate material strength. These two are the average stress, and the point stress failure criteria models presented by Whitney and Nuismer (refs. 35, 36). As described in Daniel's paper (ref. 6), the average stress failure criterion proposes that failure occurs when the average stress over a characteristic material dimension (a_0) equals the material strength. This criterion is illustrated in Figure 3-80, where a_0 represents the length dimension of a particular layup and material. Similarly, the point-stress failure criterion presented by Mikulas (ref. 7) predicts that panel failure occurs when the axial stress at some distance (d_0) from the hole boundary equals the strength of the unnotched laminate as shown in Figure 3-81. Daniel, Mikulas, and

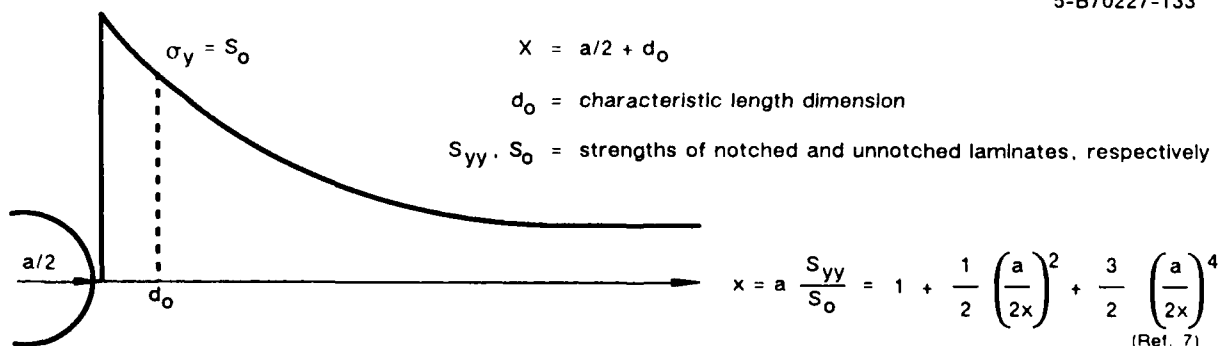
Figure 3-81. Strength Reduction of Uniaxially Loaded Hole According to Point Failure Stress Criteria

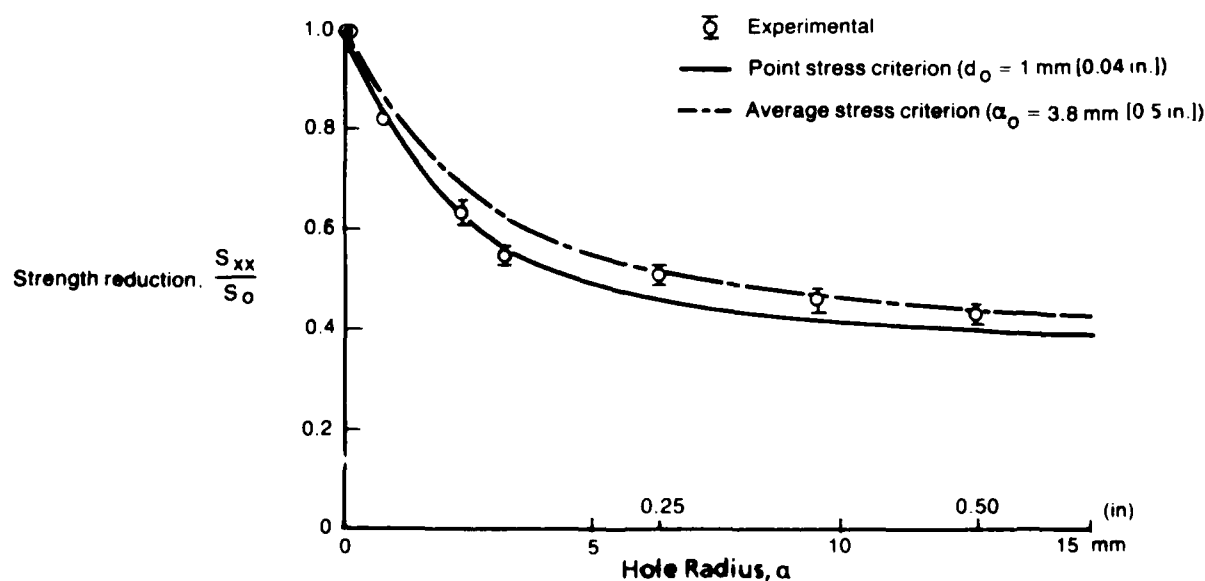
(Ref. 6. Reprinted with permission from B. R. Noton et al., "ICCM II," The Metallurgical Society, 420 Commonwealth Drive, Warrendale, Pennsylvania 15086.)

Figure 3-82. Strength Reductions as a Function of the Hole Radius for (0/+45/-45/90 deg) Graphite-Epoxy Plates With Circular Holes Under Uniaxial Tensile Loading

other investigators measured both a_0 and d_0 for a variety of layups and found a relatively good correspondence of predicted and measured strengths for open holes (Figure 3-82). The disadvantage of the point or average stress criteria is that they require different characteristic lengths for various notch sizes in the same type laminate (ref. 37 to 40).

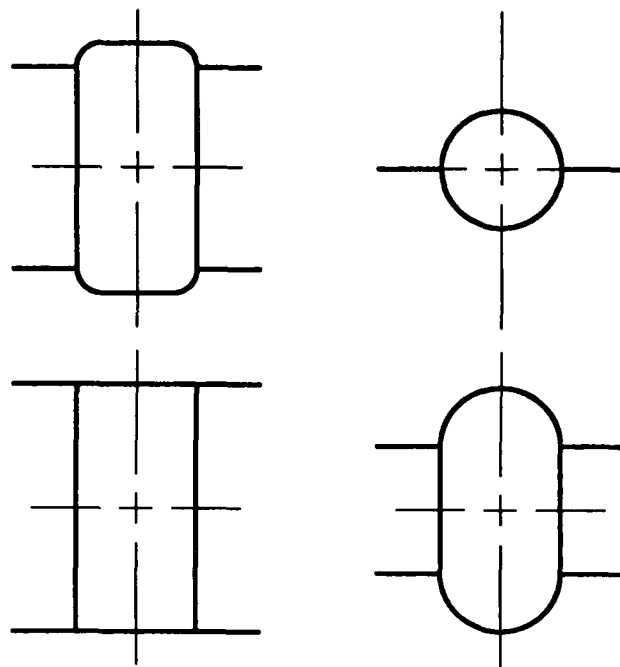
Figure 3-83. Hole Geometries Analyzed With the Damage Zone Model (DZM)

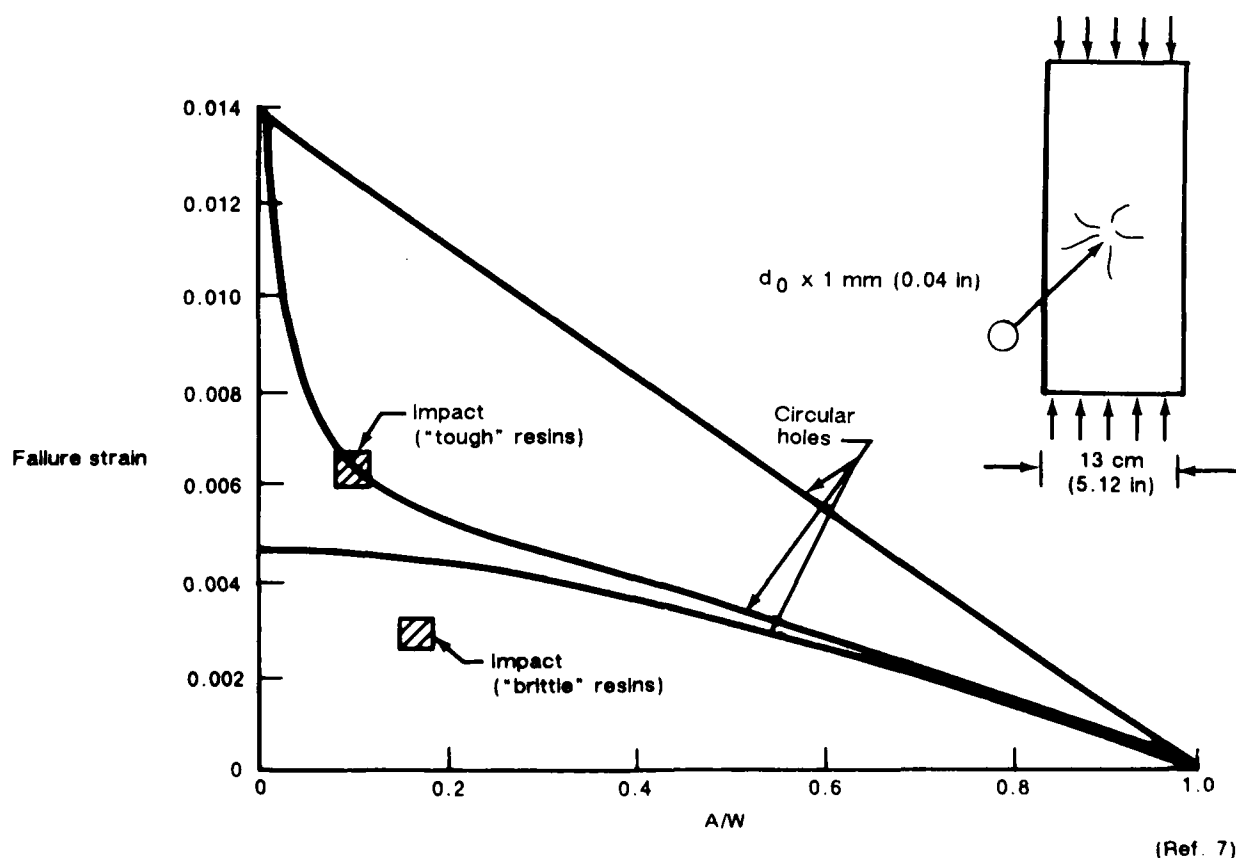
5-B70227-63

Figure 3-84. Effect of Impact Damage on the Compressive Strength of a Quasi-Isotropic Laminate

With respect to impact damage, Mikulas reported that the characteristic length d_0 depends on the toughness of the resin system examined. As illustrated in Figure 3-84, a relatively good correlation exists for tough resin chemistries, but not for brittle, delamination-prone resin systems. These observations indicate that the accuracy of failure predictions will depend strongly on the resin system used, and the configuration of damage examined. An excellent discussion of impact damage with respect to failure modes and the effects of resin toughness has been given by Starnes, Williams, and Rhodes in references 45 to 48. Their studies have clearly shown that:

1. Tough resins reduce the size of the damage zone caused by impact.
2. Several graphite/epoxy systems with varying toughness exhibited similar residual post-impact compression strength for the same damage zone size.
3. The dominant failure mechanisms causing post-impact compression failure are delamination and shear crippling.

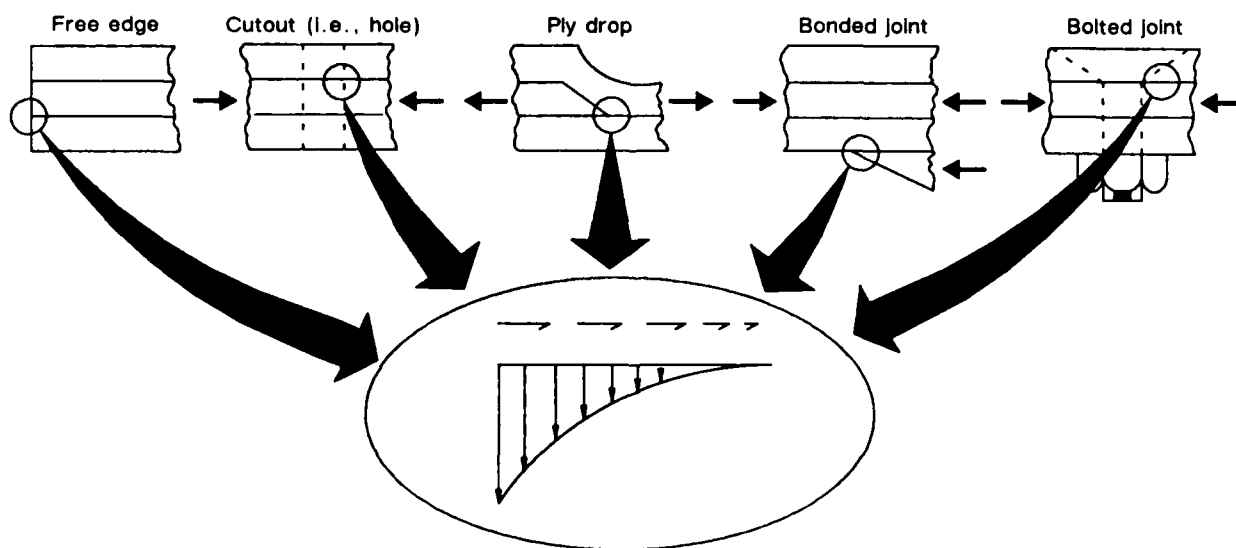
Figure 3-85. Design Details That Cause Interlaminar Stress Concentrations

As a result of processing and service conditions, delaminations may be introduced into composite structures. Fatigue and static loading of laminated composite structure may initiate delaminations near interlaminar stress concentrations. Some of the common design features found in composite structures such as bolted joints, ply drops, and cutouts contain interlaminar stress concentrations (see Figure 3-85). In addition, multiple delaminations represent characteristic post-impact damage. Local instability of a delaminated sub-region in composite structures under compressive loading precipitates out-of-plane deformations and may lead to subsequent crack growth. Under these circumstances, it has been well documented that structural strength and stiffness reductions are significant (refs. 50 to 58).

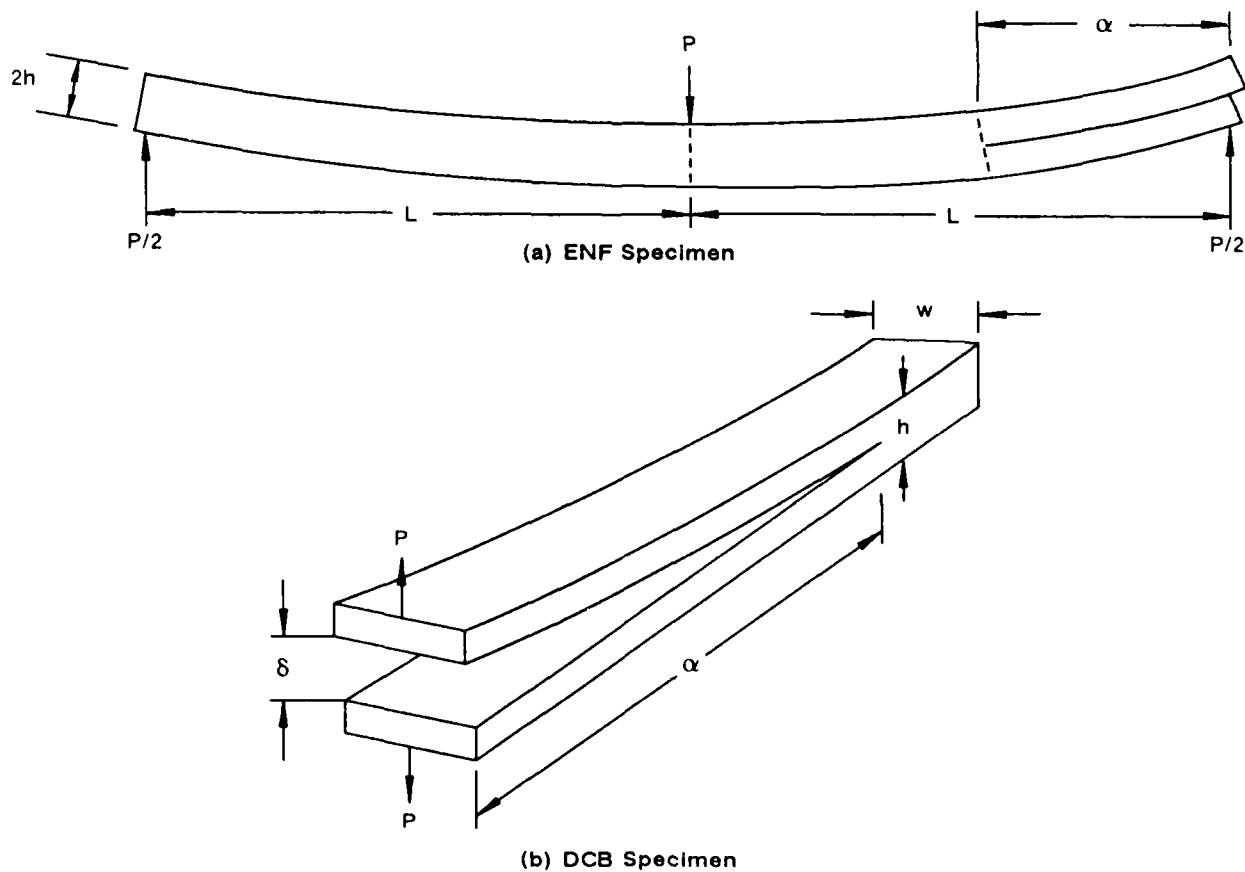
5-B70227R1-121

Figure 3-86. End-Notched Flexure (ENF) and Double-Cantilever Beam (DCB) Specimens

In the presence of interlaminar stress singularities, the fracture mechanics approach is now frequently used to assess defect criticality in composites. Double cantilever beam (DCB), Mode I, and end notched flexure (ENF) Mode II specimens, as shown in Figure 3-86 (a and b), are being used to evaluate the pure mode critical strain energy release rates. Strain energy release rates are utilized in these pure mode tests because G is a physically well defined quantity experimentally measurable with compliance calibration techniques. But, in general, cracks in composite structures are subjected to all three modes of loading at the crack tip as shown in Figure 3-87.

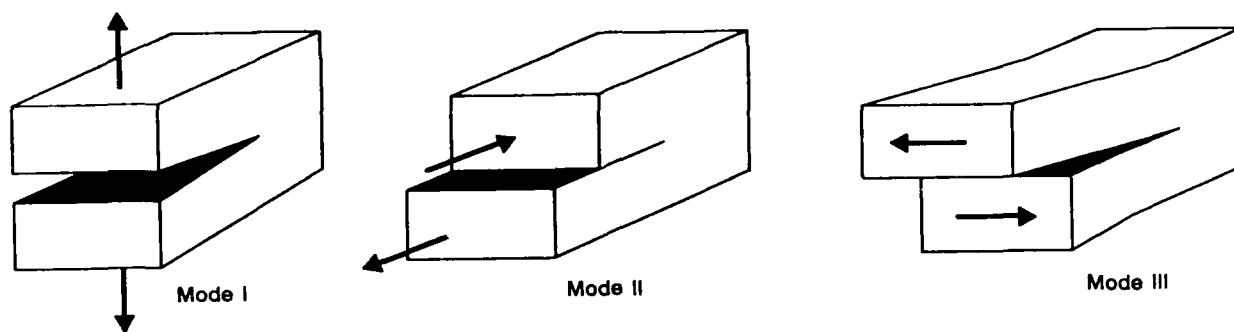
5-B70227-122

Figure 3-87. Modes of Crack Propagation

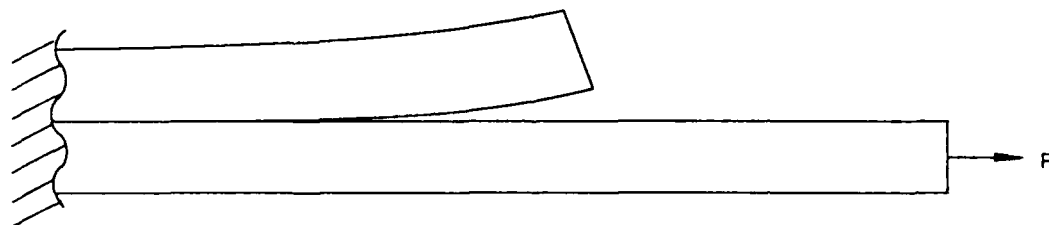
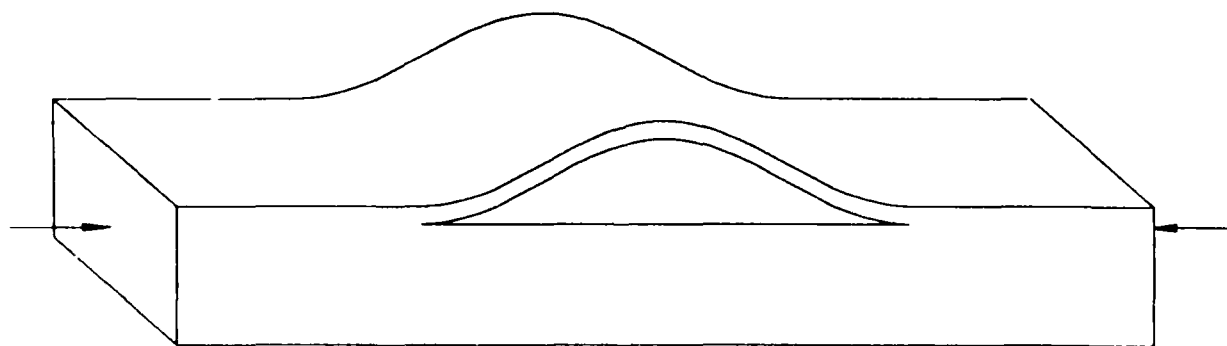
(a) Cracked Lap Shear (CLS) Specimen

(b) Imbedded Through-Width Delamination (ITWD) Specimen

Figure 3-88. Mixed Modes I and II Delamination Specimens

To study mixed-mode crack growth criteria, the imbedded through-width delamination (ITWD) and cracked lap shear (CLS) specimens shown in Figure 3-88 have been used by a

number of researchers. The opening moment and the eccentricity in load path at the crack tip of the CLS and ITWD specimens are the mechanisms causing interlaminar normal (Mode I) and shear (Mode II) stress concentrations (see Figure 3-89).

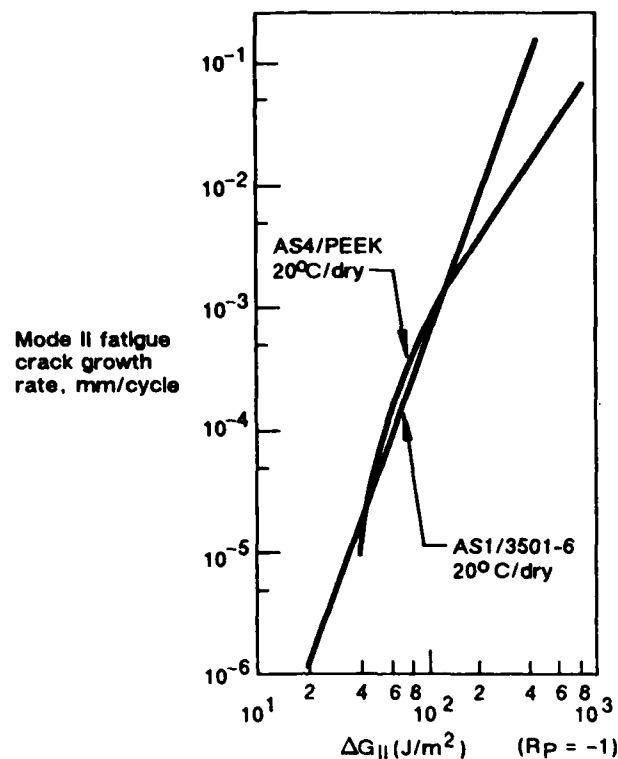
5-870227-127

Figure 3-92. Mode II Fatigue

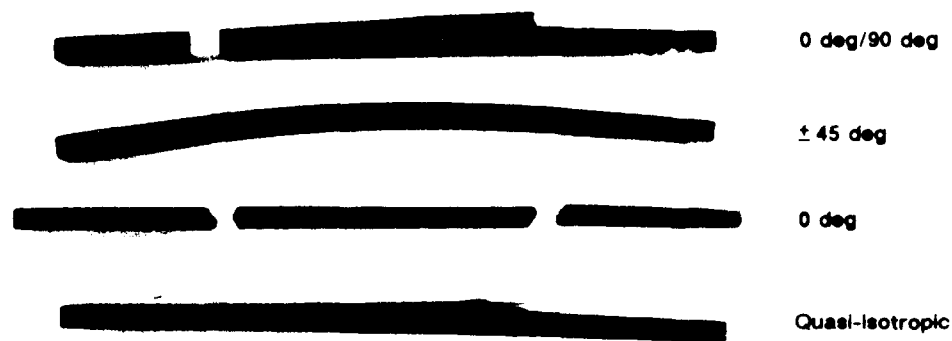
5-B70227R1-21

Figure 4-1. Laminate Flexure Specimens

Because of their laminated anisotropic construction, fractures in composites can occur in a number of complex ways. The types and modes of failure which can be encountered depends upon both the direction of applied load and the orientation of fibers (plies) making up the composite material. As indicated in Figures 4-1 and 4-2, variations in either of

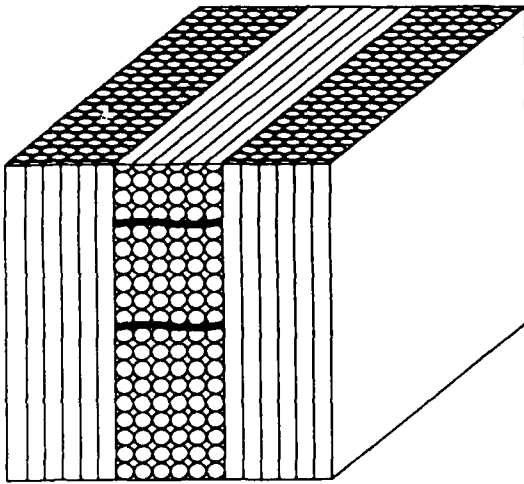
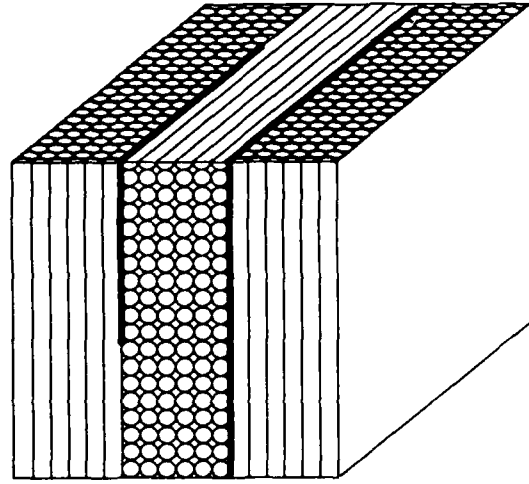
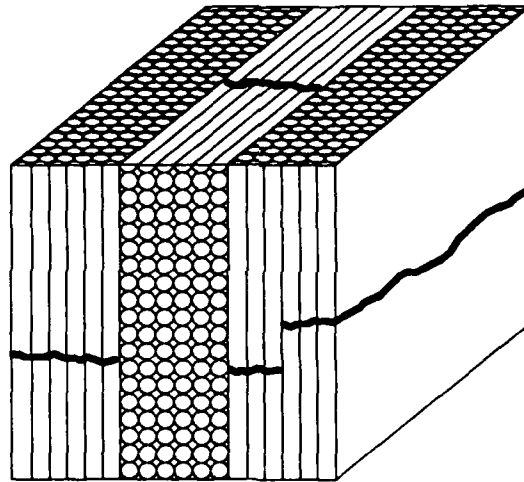
(a) Intralaminar Fracture

(b) Interlaminar Fracture

(c) Translaminar Fracture

Figure 4-3. The Basic Fracture Modes

Fractures in continuous fiber reinforced composites can be divided into three basic fracture types; interlaminar, intralaminar, and translaminar. Each of these failure types are schematically illustrated in Figure 4-3. As with the intergranular and transgranular terminology commonly used with metals, each of these classifications describes the plane of fracture with respect to the microstructural constituents of the material.

Translaminar fractures are those oriented transverse to the laminated plane in which conditions of fiber fracture are generated. Interlaminar fractures, on the other hand, describe failures oriented between plies whereas intralaminar fractures are those located internally within a ply. Translaminar fractures involve significant fiber fracture, while interlaminar or intralaminar fractures occur in the laminate plane, principally fracturing matrix resin and therefore breaking few or no fibers.

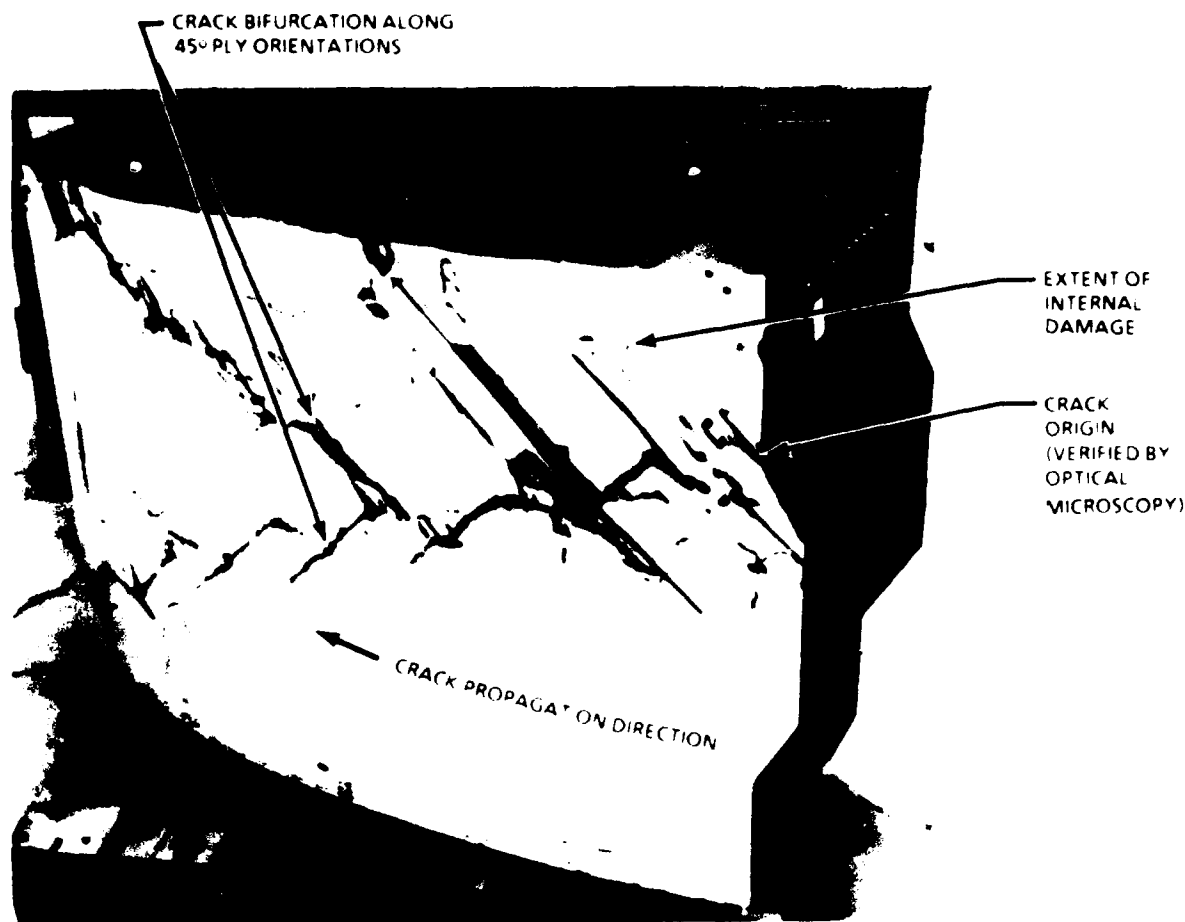
5-B70227-86

Figure 4-5. V-22 Osprey Wing Box Failure

Failures in composites can be described in terms of the failure mechanism exhibited on translaminar, interlaminar, and intralaminar fracture types. The first evaluation method available to define and differentiate between these fracture types is visual macroscopic. The ability to define fracture types at the macroscopic level can often be the most valuable capability for many investigators, particularly for those performing field investigations. When examining a failed composite structure, the investigator must assess the nature and direction of the applied load, identify the significance and time of fracture, and select portions of the structure for laboratory analyses. Visual examination alone can often provide sufficient information to answer these questions. However, this extremely valuable capability is very much in its infancy compared to the metals field. Figure 4-4 presents a brief overview of the relationships that various investigators have observed between fracture mode/load conditions and macroscopic fracture surface features. Figure 4-5 illustrates how a consistent pattern of crack branching of the skin surface was found to indicate the direction of macroscopic crack growth, and aided in identifying the initiation site in a very large structure which experienced compression buckling.

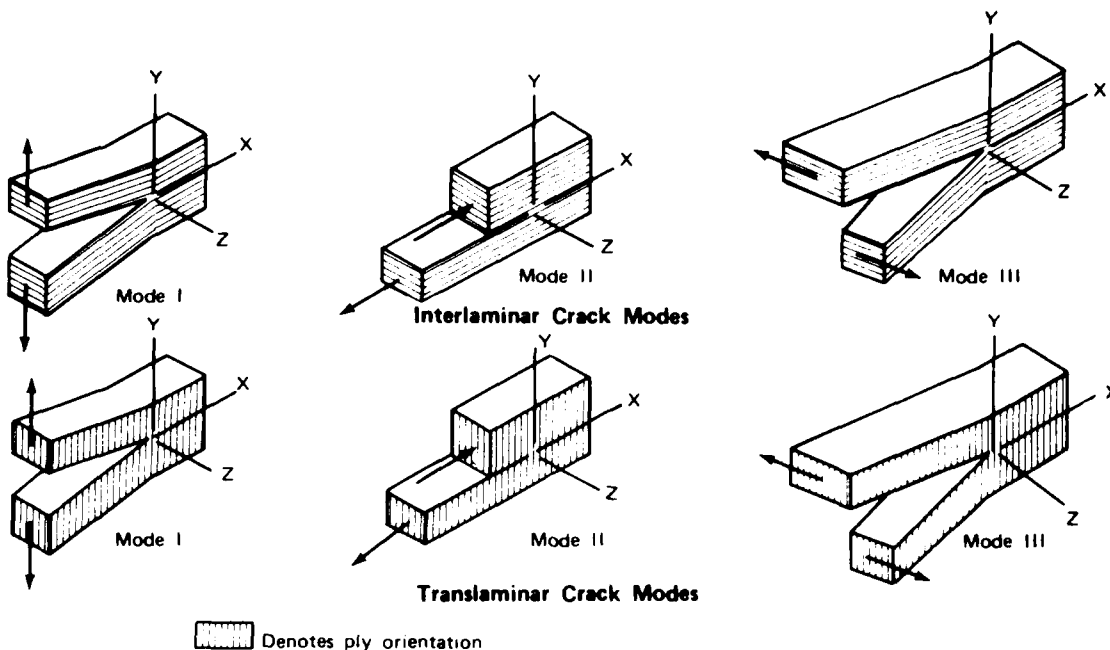
5-B70227-65

- Mode I Opening or tensile mode, where the crack surfaces move directly apart.
- Mode II Sliding or in-plane shear mode, where the crack surfaces slide over one another in a direction perpendicular to the leading edge of the crack.
- Mode III Tearing or antiplane shear mode, where the crack surfaces move relative to one another and parallel to the leading edge of the crack.

Figure 4-6. Basic Modes of Loading Involving Different Crack Types and Surface Displacements (Interlaminar and Translaminar)

fiber reinforcement. In a manner similar to that described for metals, fracture of either type can occur under Mode I tension, Mode II in-plane shear, Mode III anti-plane shear. These three load states are illustrated in Figure 4-6. On a microscopic scale, nearly all delaminations separate in a combination of the first two types, with a predominance of either one or the other. All modes are recognized as potentially critical in compression buckling, joint failures, and defect initiated failures such as impact. Each of these failure modes are still being actively investigated so as to further understand the actual microstructural separation mechanisms and the generated morphological features, as related to the macroscopic loading conditions. As a result, conditions such as Mode III anti-plane shear have not been thoroughly studied and will not be presented in this document. However, for Mode I tension and Mode II in-plane shear, enough data exists to accurately model their mechanisms of separation and describe their fracture characteristics.

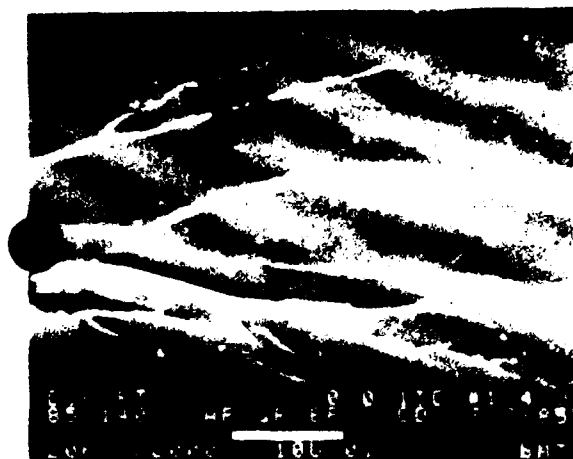
5-B70227-87

Vertical arrow indicates crack direction

- Legend:
 M Matrix fracture
 F Fiber fracture
 P Fiber/polymer separation
 S Surface morphology

Figure 4-12. SEM Fractographs of Mode I Delamination Between 0/0-deg Plies

The river markings, presented in Figure 4-12, are analogous to the cleavage fracture features commonly recognized in brittle materials such as metals, ceramics, and polymers. It has been determined through extensive studies that such features result from progressive joining of adjacent microscopic fracture planes during crack growth. More specifically, each line segment represents a local step formed when the thin ligament separating two adjacent planes is fractured during crack growth. As presented by Griffith (ref. 59), the amount of strain energy involved in fracture is proportional to the area of fracture surface created and the amount of plastic deformation at the crack tip. As a result, a large number of locally displaced fracture planes that initiate at the fiber/matrix interface represent a higher energy condition than a single continuous fracture surface. Since crack propagation tends to occur along the path requiring the least energy, there is a tendency for the planes to coalesce together. Thus the multitude of microplanes that initiate at the fiber/matrix interface link up as the crack propagates, resulting in a coalescence of the steps to form a branched pattern, or river marks.

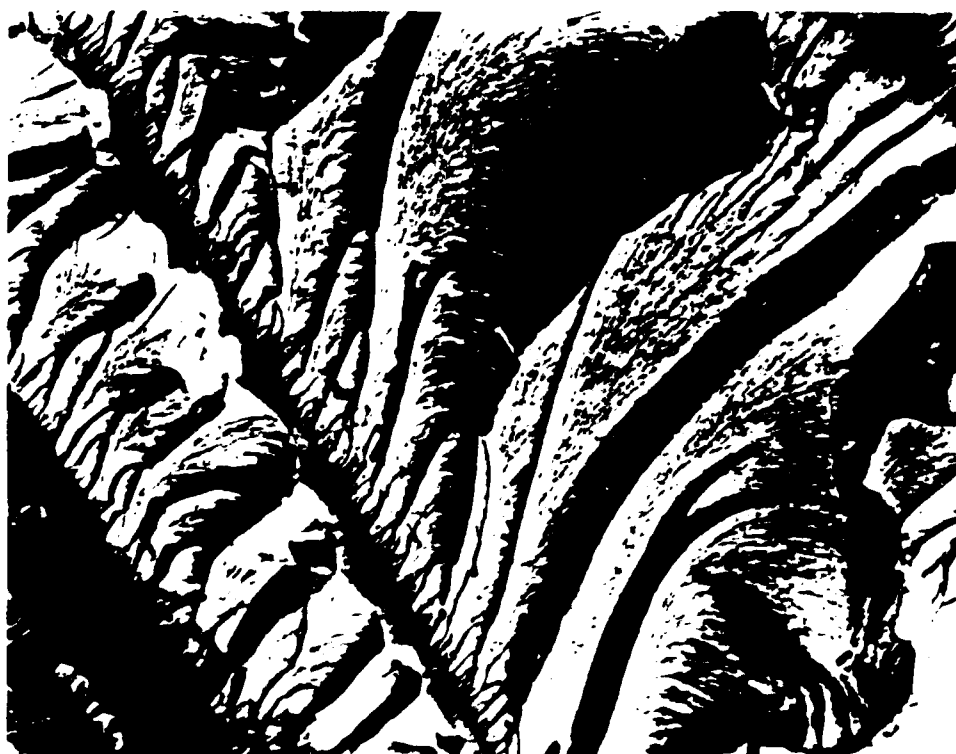
Figure 4-14. TEM Image of Resin Microplane With River Marks and Resin Microflow

Close inspection of the resin microplanes exhibit a distinctly textured morphology referred to as resin microflow. Microflow is discernable at high magnifications and usually requires tilting of the specimen in the SEM (Figures 4-13 and 4-14) for this subtle feature to become visible. In many ways, the textured appearance is identical to the cleavage feathers characteristic of metallic fractures as shown in Figure 4-7. These feathery patterns exhibit a distinctive chevron type appearance, with the pointed end of the chevron oriented toward the origin of propagation. This chevron pattern results from the inherent tendency of a propagating crack to take the shortest path to a free surface. On a microscopic scale, these chevrons tend to rotate from the direction of overall crack growth toward adjacent free surfaces such as microplanes, transverse cracks, or fiber/matrix interfaces. However, by examining the direction and orientation of the microflow patterns in the center of each microplane, the localized direction of crack propagation can be determined.

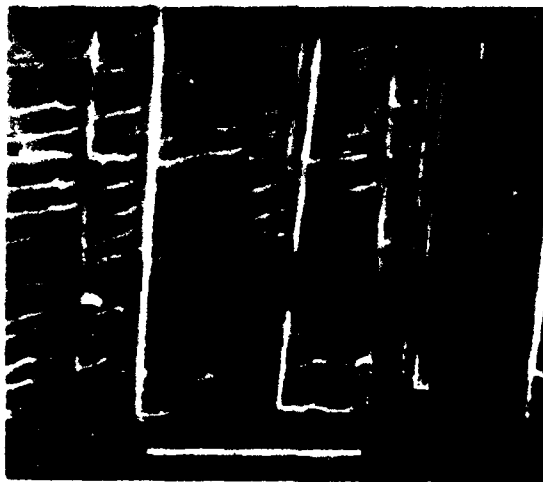
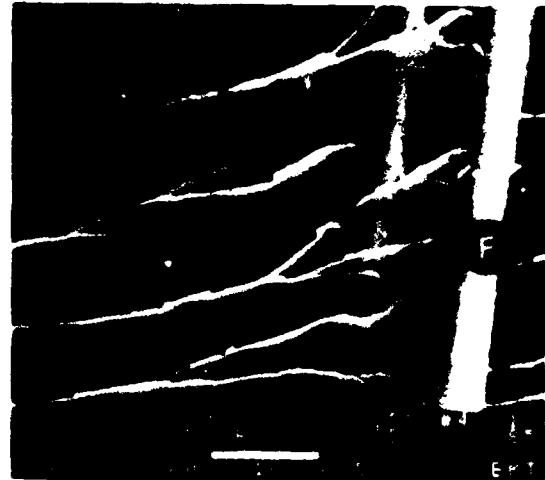
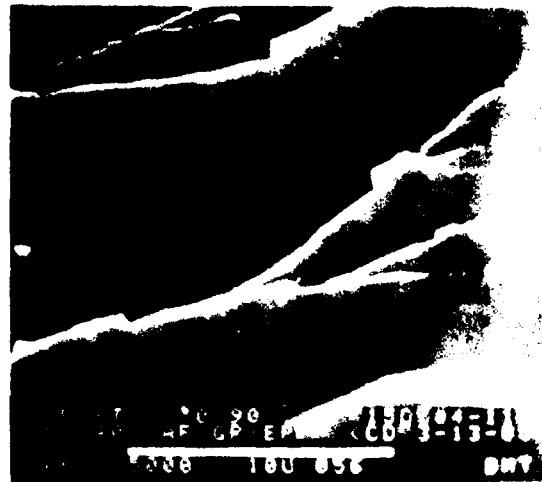
5-B70227-90

Mechanically induced crack direction

- M Matrix fracture
- F Fiber matrix separation
- R River markings
- T Textured microflow

Figure 4-15. SEM Photomicrographs of Mode I Delamination Between 0/90-deg Plies

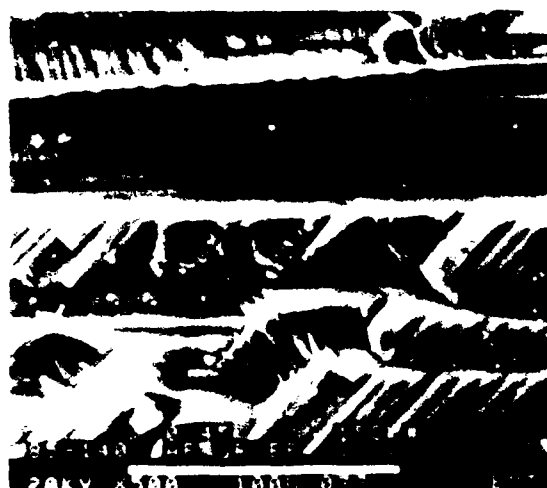
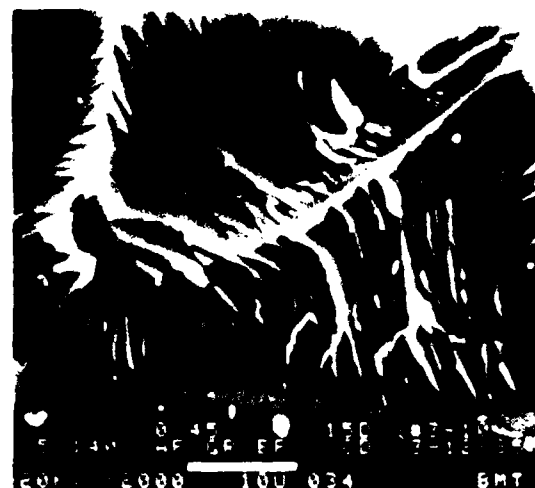
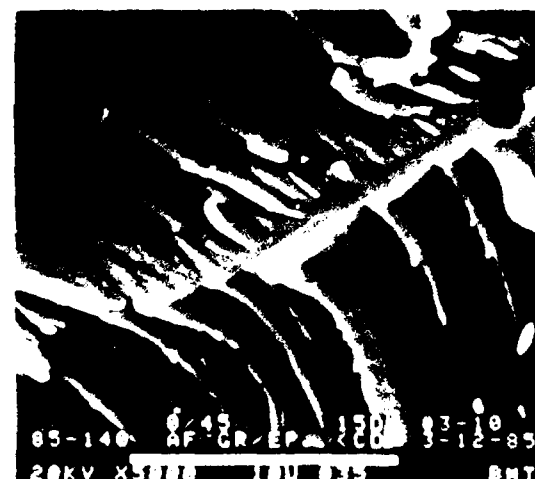
5-B70227-92

Mechanically induced crack direction

- M Matrix fracture
- F Fiber matrix separation
- R River markings
- T Textured microflow

Figure 4-16. SEM Photomicrographs of Mode I Delamination Between 0/+45-deg Plies

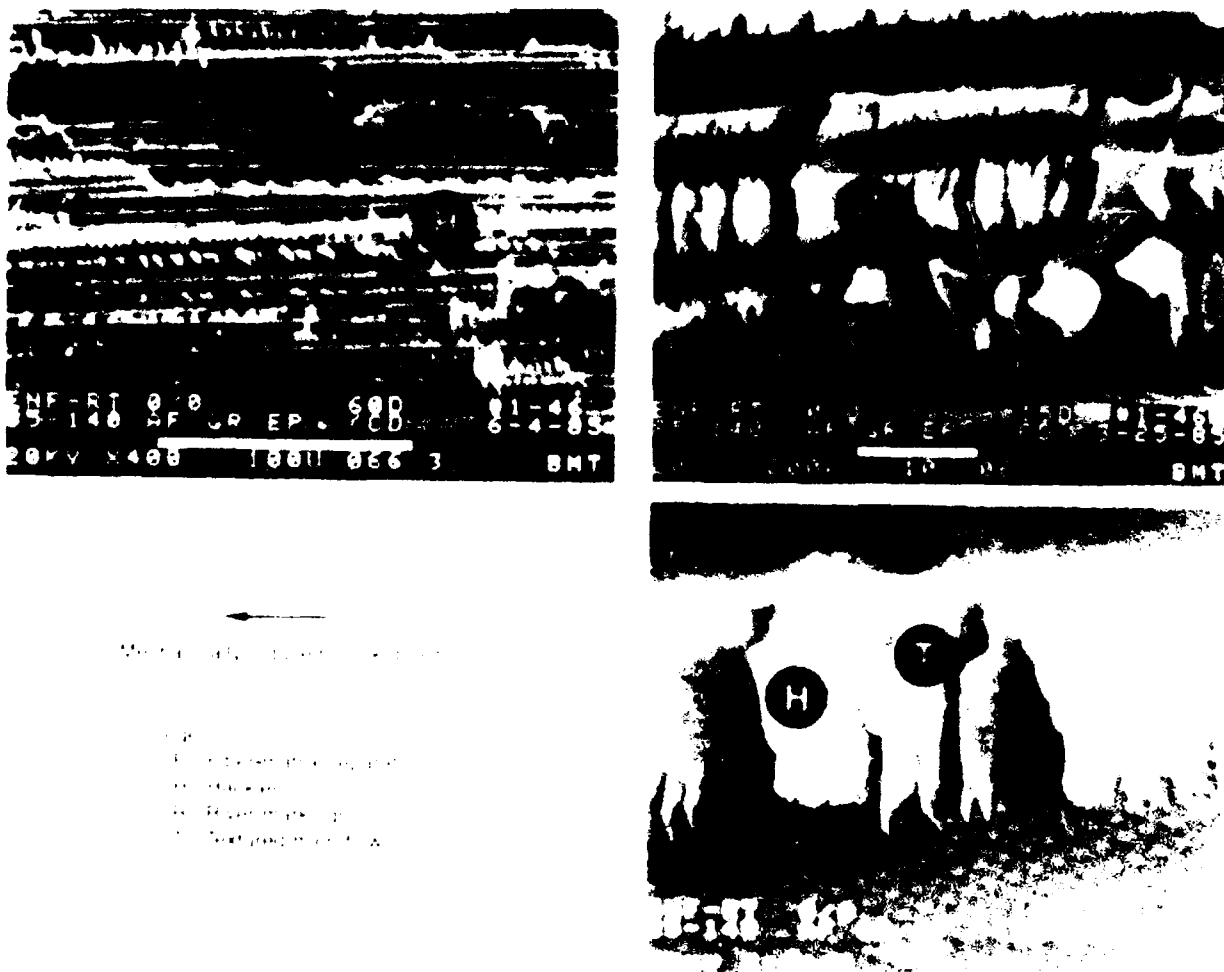
Figure 4-19. SEM Photomicrographs of Mode II Delamination Between 0/0-deg Plies

Under detailed SEM examination (Figure 4-19), the rows of curved vertical platelets are found in the cohesive resin fracture regions between fibers. As described by Mohr's circle, during in-plane shear loading the principle tensile stresses are oriented at forty-five degrees to the plane of applied shear, as shown in Figure 4-20. Since matrix fracture occurs in a microscopic plane normal to resolved tensile stress, a series of distinct inclined microcracks (Figure 4-21) are formed ahead of the main crack front. Increased strain or loading causes these small parallel microcracks to grow and coalesce, resulting in the formation of a series of upright curved platelets. Based upon these observations, the directions of applied shear (clockwise or counterclockwise moment) can be determined by examining the direction of platelet tilt. Concave areas are found on the mating fracture surfaces, opposite to these platelets (Figure 4-22). High magnification inspection of the platelets and the concave regions reveals small river marks and microflow, also indicative of resolved tensile separation. Several terms have been used to describe each
